Impervious Cover Reduction Action Plan for Readington Township, Hunterdon County, New Jersey

Prepared for Readington Township by the Rutgers Cooperative Extension Water Resources Program

November 16, 2015

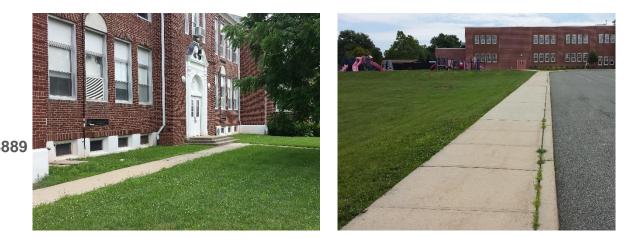
Subwatershed:	Chambers Brook
Site Area:	279,683 sq. ft.
Address:	50 Whitehouse Avenue Whitehouse Station, NJ 088
Block and Lot:	Block 35, Lot 14

On the east side of the school a bioretention system can be installed to capture, treat, and infiltrate roof runoff by disconnecting and redirecting the nearby downspouts. A second rain garden can be built on the south side to treat roof runoff as well. Runoff from the play area can be captured by making curb cuts and constructing a rain garden in the turf grass area adjacent to it. Parking spaces can be replaced with pervious pavement to infiltrate additional stormwater. A preliminary soil assessment suggests that the soils have suitable drainage characteristics for green infrastructure.

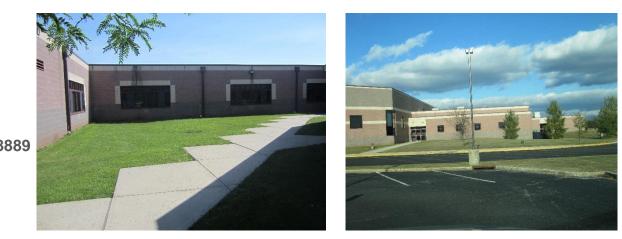
Subwatershed:	Holland Brook
Site Area:	2,050,634 sq. ft.
Address:	52 Readington Road Whitehouse Station, NJ 088
Block and Lot:	Block 48, Lot 21.28

The school's stormwater appears to drain primarily through connected downspouts with some disconnected downspouts flowing into turf grass. There are multiple locations where rain gardens can be installed to capture, treat, and infiltrate roof runoff by disconnecting and redirecting downspouts. Runoff from the parking lot can be infiltrated by using pervious pavement. A preliminary soil assessment suggests that more soil testing would be required before determining the soil's suitability for green infrastructure.

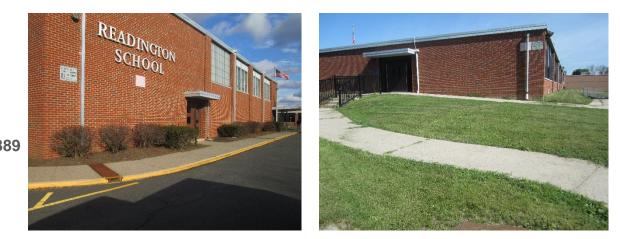
Subwatershed:	Holland Brook
Site Area:	947,054 sq. ft.
Address:	48 Readington Road Whitehouse Station, NJ 0888
Block and Lot:	Block 48, Lot 21.01

There are several locations where rain gardens can be installed to capture, treat, and infiltrate roof runoff. The parking lot runoff can be treated by creating curb cuts to direct rainwater into rain gardens using the detention basin as an overflow. A preliminary soil assessment suggests that more soil testing would be required before determining the soil's suitability for green infrastructure.

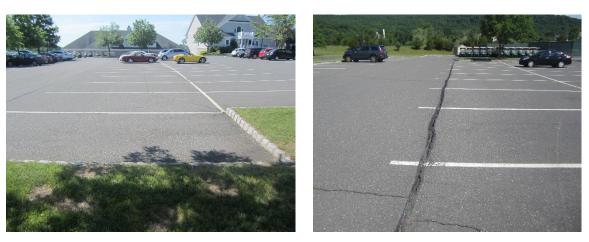
Subwatershed:	Holland Brook
Site Area:	2,037,878 sq. ft.
Address:	25 Club House Drive Whitehouse Station, NJ 08889
Block and Lot:	Block 51, Lot 21.28

The country club's parking lot runoff flows toward the northeast and into catch basins along the way. Strips of pervious pavement can replace the existing asphalt to capture this runoff and allow it to infiltrate. A preliminary soil assessment suggests that the soils have suitable drainage characteristics for green infrastructure.

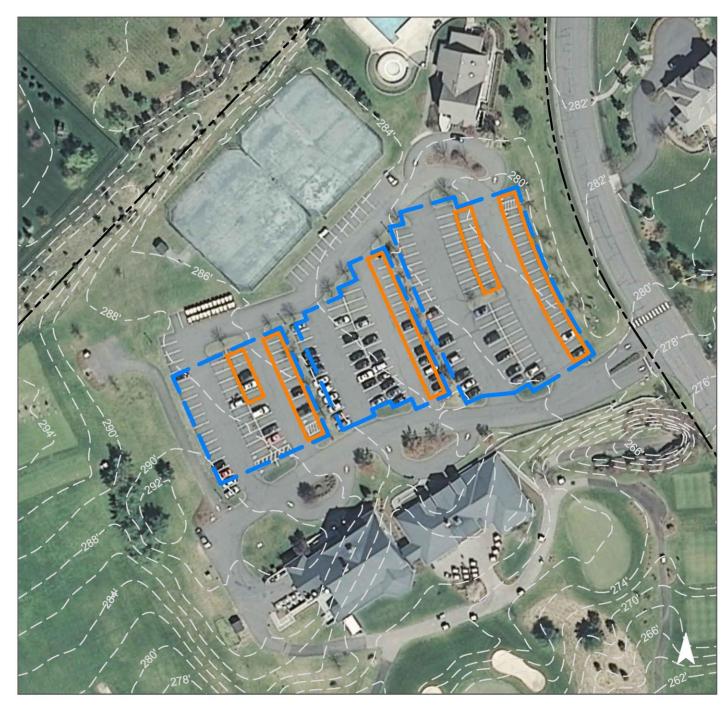
Stanton Ridge Golf & Country Club

- pervious pavements
- drainage areas
- **[]** property line
- 2012 Aerial: NJOIT, OGIS

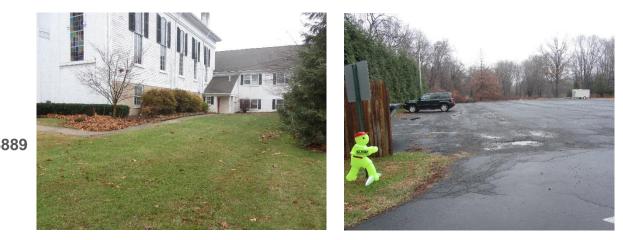
Subwatershed:	Lamington River
Site Area:	104,744 sq. ft.
Address:	73 Old Highway 28 Whitehouse Station, NJ 088
Block and Lot:	Block 13, Lot 36

The church's stormwater comes from the roof which flows down primarily disconnected downspouts, and the parking lot that drains into the neighboring woods. Bioretention systems can be installed on the south and east sides of the building to capture, treat, and infiltrate roof runoff. The parking lot runoff can be captured by replacing parking spaces with pervious pavement. A preliminary soil assessment suggests that the soils have suitable drainage characteristics for green infrastructure.

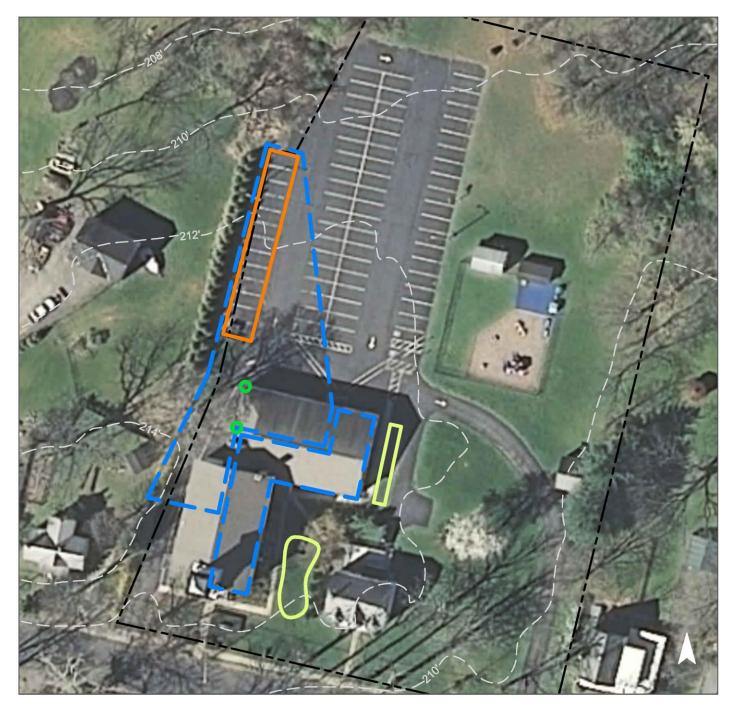
Whitehouse United Methodist Church

- disconnected downspouts
- pervious pavements
 - bioretention / rain gardens
- drainage areas
- [] property line
- 2012 Aerial: NJOIT, OGIS

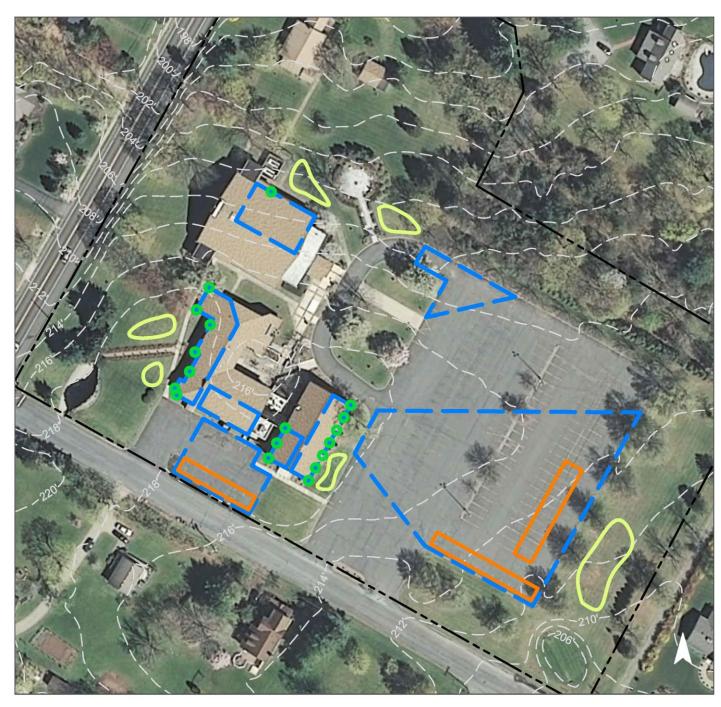
Our Lady of Lourdes

The parking lot runoff currently drains into a detention basin at the south end. Parking spaces can be replaced with pervious pavement to capture and infiltrate stormwater. Additional runoff from the parking lot can be captured, treated, and infiltrated by installing rain gardens. The roof runoff flows down connected downspouts, which can be disconnected into rain gardens. A preliminary soil assessment suggests that the soils have suitable drainage characteristics for green infrastructure.

- disconnected downspouts
- pervious pavements
 - bioretention / rain gardens
- drainage areas
- [] property line
 - 2012 Aerial: NJOIT, OGIS

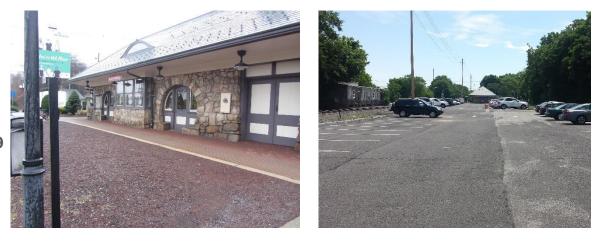
Subwatershed:	Rockaway Creek
Site Area:	94,573 sq. ft.
Address:	255 Main Street Whitehouse Station, NJ 08889
Block and Lot:	Block 22, Lot 100, 102

The library runoff drains into connected downspouts. The runoff from the parking lot flows primarily toward the railroad tracks although some is caught by catch basins. Parking spaces can be replaced with pervious pavement to capture and infiltrate stormwater. A preliminary soil assessment suggests that the soils have suitable drainage characteristics for green infrastructure.

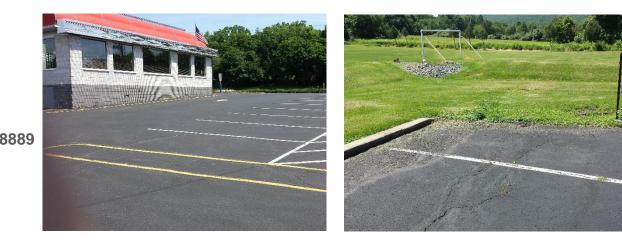
Subwatershed:	Rockaway Creek
Site Area:	179,075 sq. ft.
Address:	283 Us Highway 22 Whitehouse Station, NJ 08
Block and Lot:	Block 20, Lot 2,3

The diner's stormwater primarily comes from the parking lot, which flows into the surrounding field and gravel area at the east end. The runoff from the east area can be captured by replacing parking spaces with pervious pavement. Runoff from the southeast area can be captured, treated, and infiltrated by installing a bioretention system. A preliminary soil assessment suggests that the soils have suitable drainage characteristics for green infrastructure.

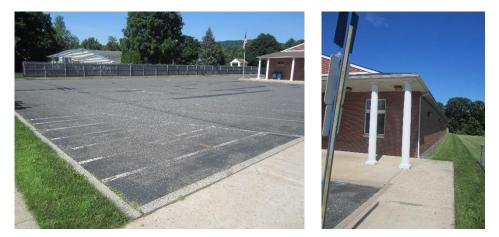
Subwatershed:	Rockaway Creek
Site Area:	122,167 sq. ft.
Address:	273 Main Street Whitehouse Station, NJ 08889
Block and Lot:	Block 22, Lot 42

The parking lots drain to catch basins. The rooftop runoff from the north side can be treated by adding gutters and directing water into a rain garden on the fire department's property if permission was granted. The south side roof runoff can be treated by replacing the sidewalk with pervious pavement. Parking spaces can be replaced with pervious pavement to capture and infiltrate stormwater. A preliminary soil assessment suggests that the soils have suitable drainage characteristics for green infrastructure.

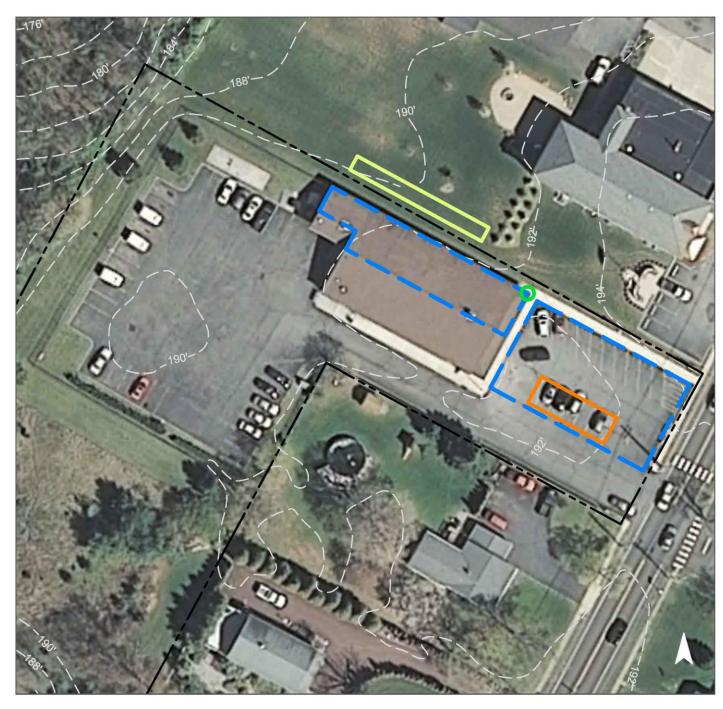
US Post Office

- disconnected downspouts
- pervious pavements
 - bioretention / rain gardens
- drainage areas
- [] property line
- 2012 Aerial: NJOIT, OGIS

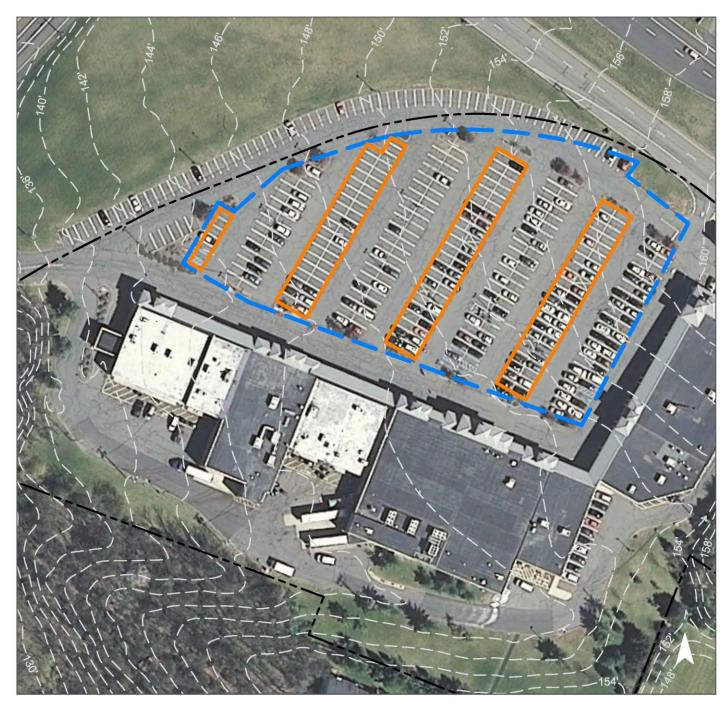
Whitehouse Mall

Parking spaces can be replaced with pervious pavement to capture and infiltrate stormwater. A preliminary soil assessment suggests that the soils have suitable drainage characteristics for green infrastructure.

- pervious pavements
- drainage areas
- **[]** property line
 - 2012 Aerial: NJOIT, OGIS

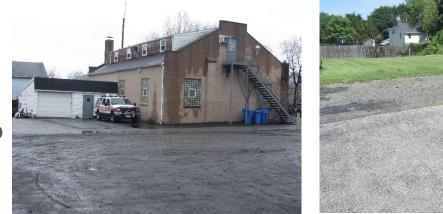
The rescue squad's stormwater comes from its paved areas, which drain toward the northwest turf grass area. The rooftop runoff flows down disconnected downspouts. The paved runoff in the front can be infiltrated by replacing parking spaces with pervious pavement. The runoff from the building can be harvested inside a cistern, which can be used for washing vehicles. A bioretention system can be constructed in the turf grass behind the building to capture, treat, and infiltrate runoff. A preliminary soil assessment suggests that the soils have suitable drainage characteristics for green infrastructure.

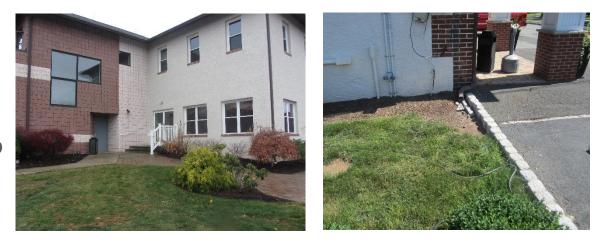
Subwatershed:	Rockaway Creek
Site Area:	79,776 sq. ft.
Address:	271 Main Street Whitehouse Station, NJ 08889
Block and Lot:	Block 22, Lot 47

The fire station primarily has internal drainage with connected downspouts on the south and east sides. The paved areas drain either toward the street, the northern turf grass and wooded area, or to the neighboring rescue squad. A bioretention system can be built on the south face where the nearby downspouts can be disconnected and redirected into it to capture, treat and infiltrate roof runoff. A preliminary soil assessment suggests that the soils have suitable drainage characteristics for green infrastructure.

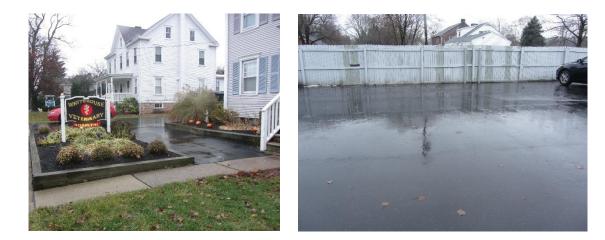
Subwatershed:	Rockaway Creek
Site Area:	14,016 sq. ft.
Address:	274 Main Street Whitehouse Station, NJ 08889
Block and Lot:	Block 29, Lot 10

The runoff from the building flows down disconnected downspouts onto the driveway and turf grass. The parking lot and driveway runoff drain into the roadways. A bioretention system can be constructed on the south face to capture, treat, and infiltrate rooftop runoff. Parking spaces can be replaced with pervious pavement to capture and infiltrate stormwater. A preliminary soil assessment suggests that the soils have suitable drainage characteristics for green infrastructure.
